**Executive Summary**

This is the procedure to upgrade the BIOS on a ESY22i2.

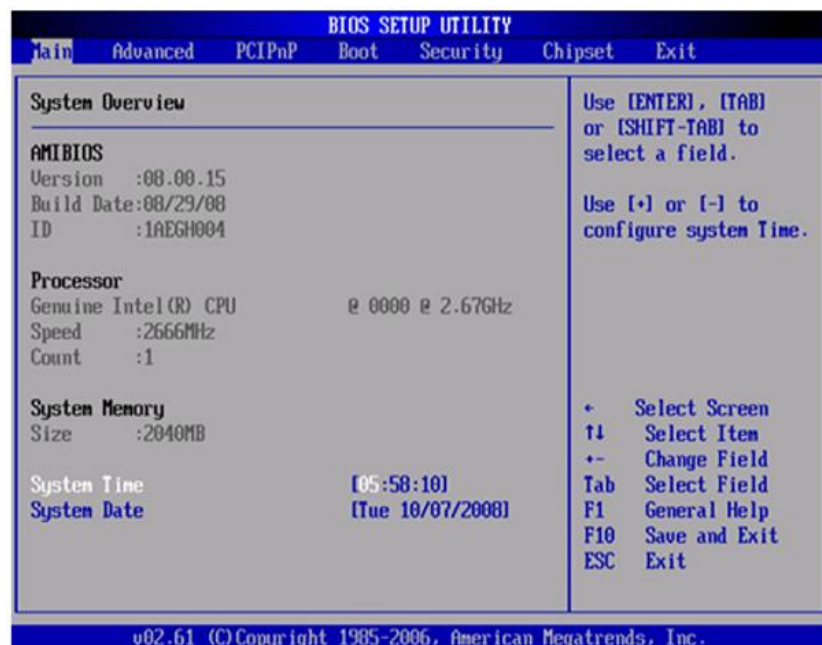
1. Power on the device.
  - a. Press power button on back of unit.
  - b. As system is booting up, press the **DEL** on a connected keyboard to enter the BIOS. (Alternatively, you can touch the **SETUP** icon in the upper right corner of the screen to enter BIOS).

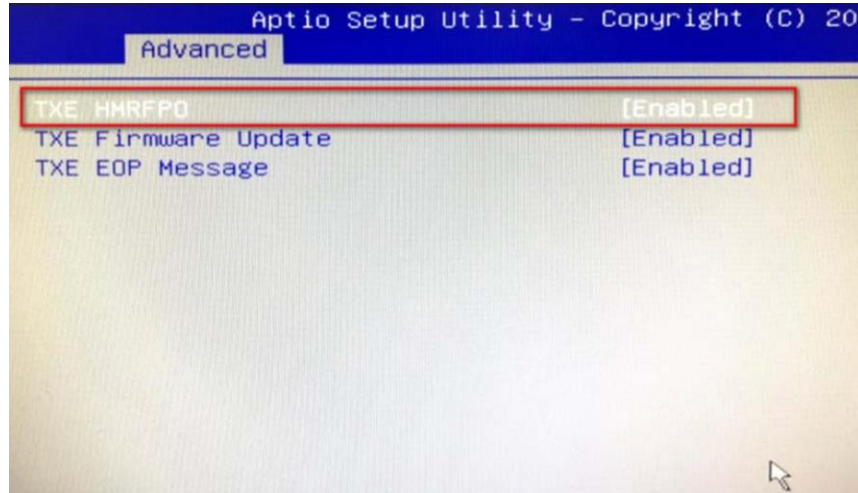
2. Enable TXE Setting.
  - a. Navigate to menu option: **Advanced -> Security -> Configuration -> TXE HMRFP0**
  - b. **“Enable”** the setting.

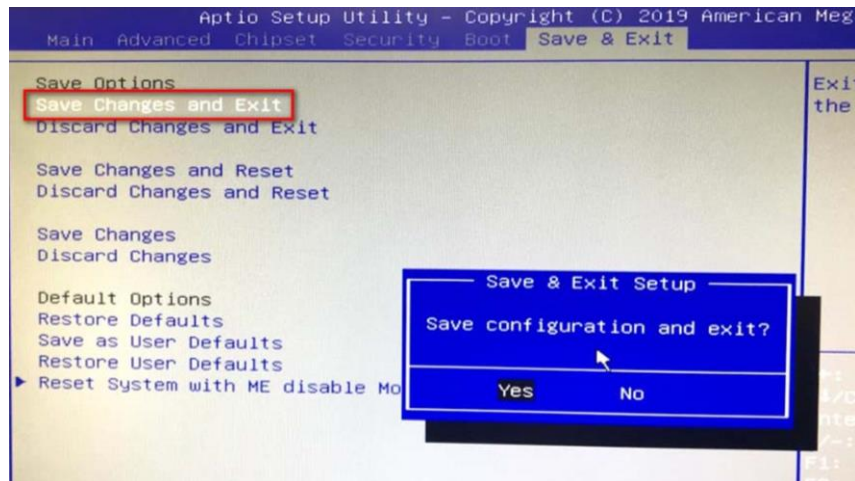
3. Save the BIOS changes.
  - a. Navigate to menu option: **Save & Exit -> Save Changes and Exit**
  - b. **“Yes”** – to commit the changes

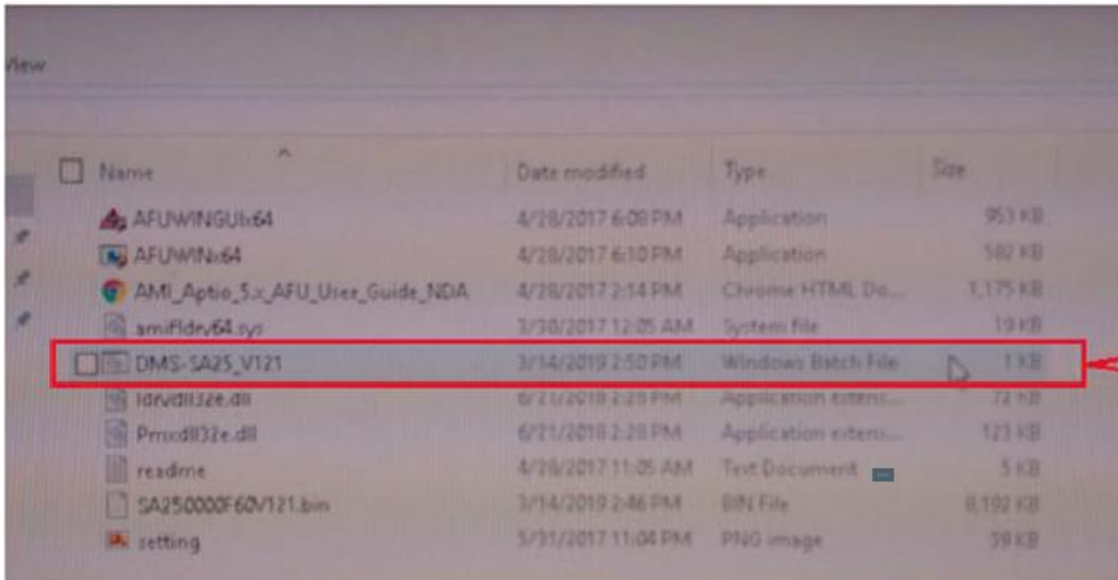
4. Upgrade the BIOS
  - a. Boot into the Operating System
  - b. Navigate to provided BIOS upgrade file(s)
  - c. Double-click the file: "**DMS-SA25\_V121**"

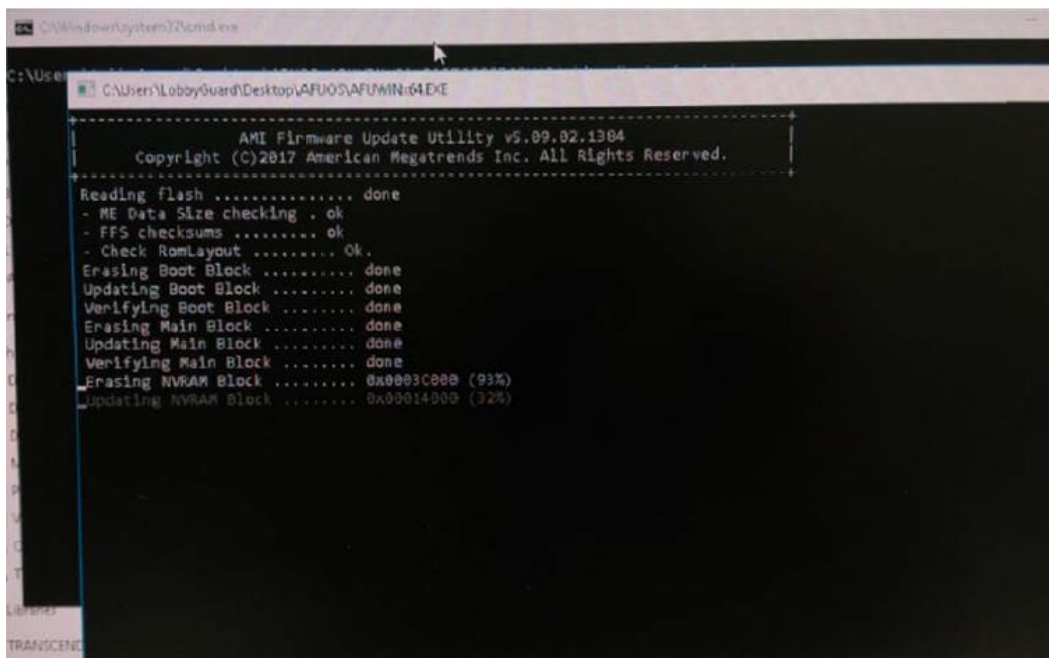
- d. Allow the process to run. When the update is successful the system will prompt to reboot. Allow to system to fully process update

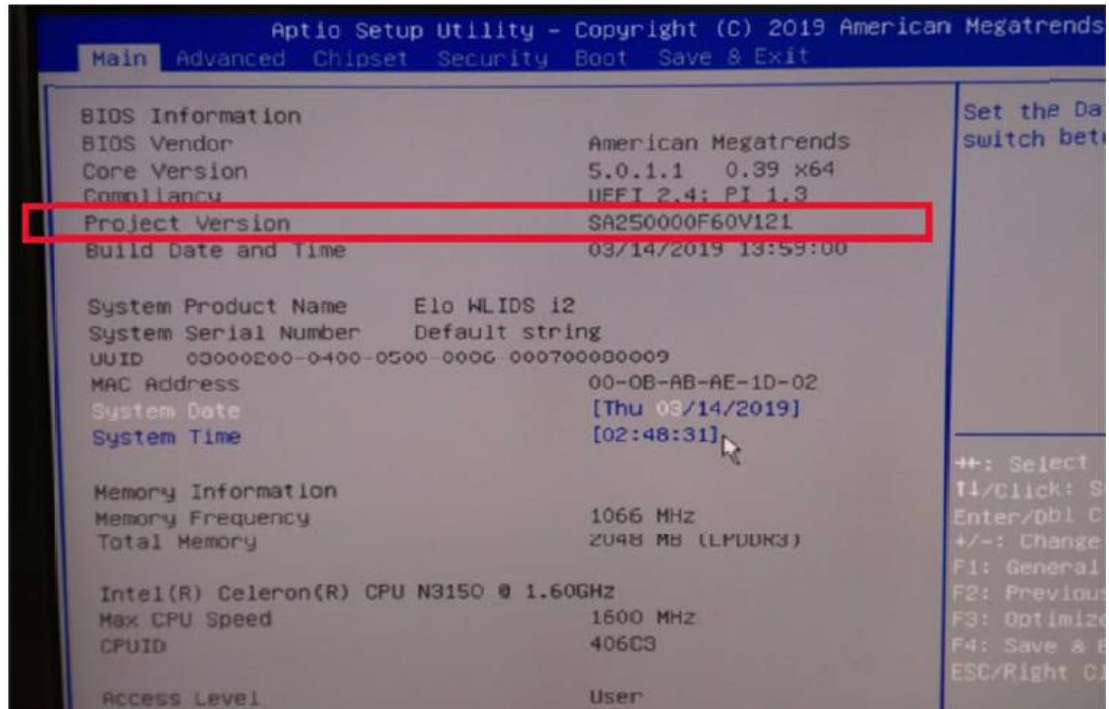
## 5. Verify BIOS Update.

- a. After the DEVICE restarts press "**Delete**" on the Keyboard
- b. Menu option "**Main**"
- c. Verify the BIOS – "**Project Version**" SA250000F60V121
